# Repairing Large Delaminated Overlays with Epoxy Injection

By John F. Trout

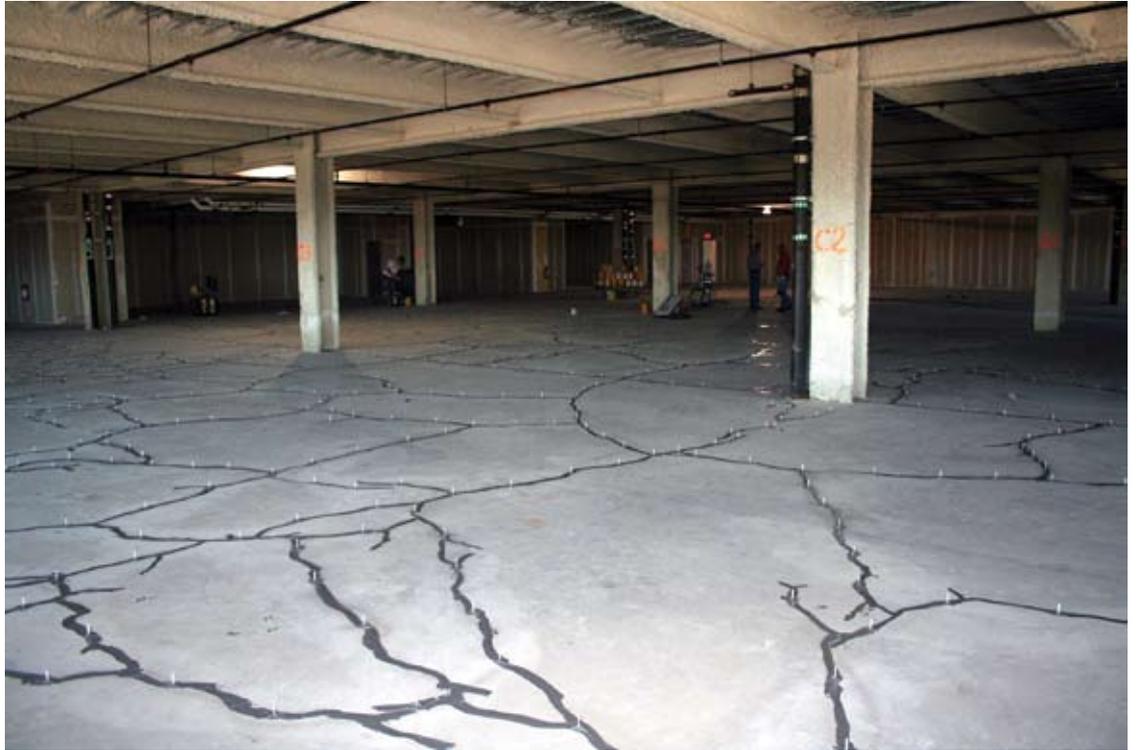
Fig. 1

**T**he mother of all delaminations!” was the apt characterization of one observer upon visiting the 128,000 ft<sup>2</sup> (11,682 m<sup>2</sup>) overlay (refer to Fig. 1). At least 50% of the area had lost bond. In addition, there were miles of cracks and many construction joints had separated—over 17,000 linear feet (5182 m) combined.

Had time and accessibility allowed, wisdom may have dictated reducing the overlay to rubble, scooping it up, and starting over. But the floor was in the upper reaches of a high-rise and was needed within 2 months. Epoxy injection was deemed the only feasible repair.

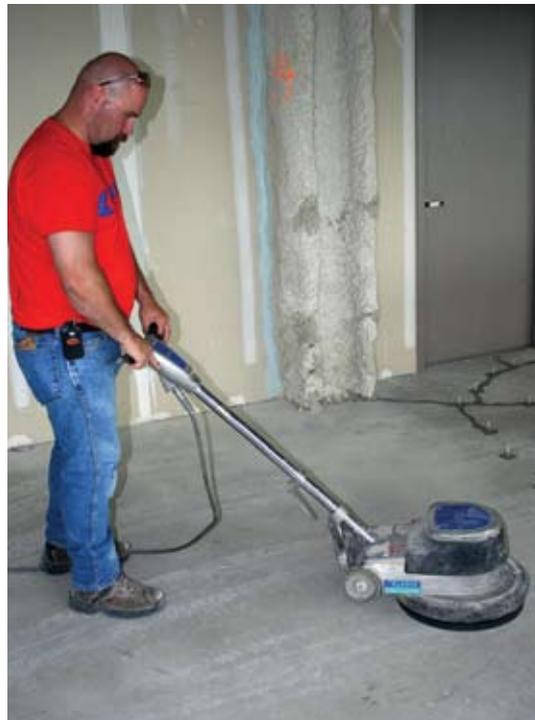
Fig. 4

It was quickly realized that a sweep of the entire floor with a 16 in. (40 cm) floor sander followed by a vacuum was more productive than tracing each crack with a hand wire brush or power tool (refer to Fig. 4). The cracks were air blasted to remove any impacted fines shortly before application of the epoxy crack sealer.

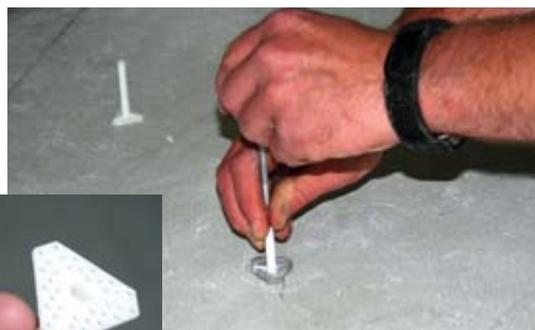
Fig. 6

A special setting tool was helpful in positioning the surface mounted porting adapters along the cracks and joints. The sealer used to secure the adapters was the same as that used to seal the cracks (refer to Fig. 5, 6, and 7). The adapters were spaced on nominal 12 in. (30 cm) centers.

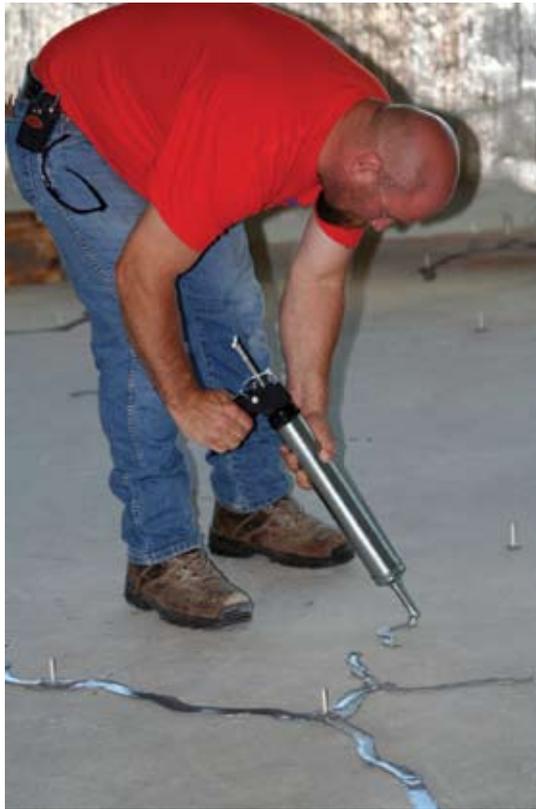
Fig. 8

Caulking guns were used to deposit the sealer along the cracks. The seal was then tooled as necessary (refer to Fig. 8).

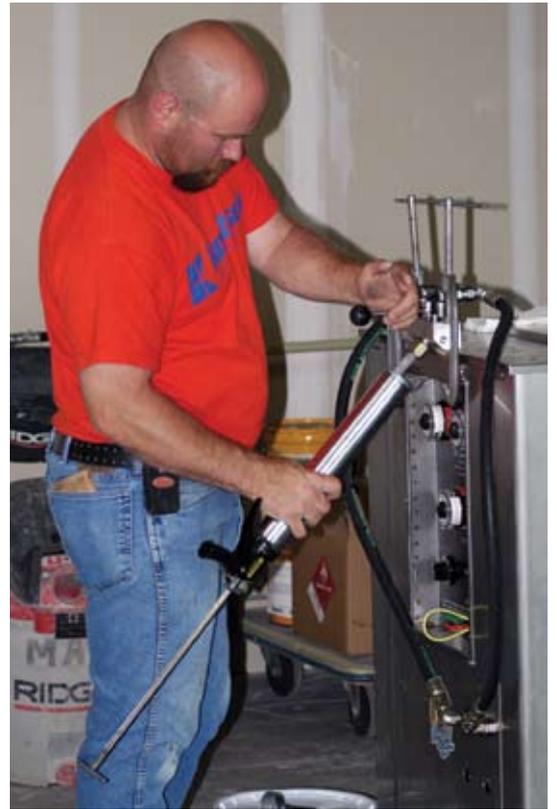
The hydrant concept was invaluable, providing thoroughly mixed and precisely proportioned material "on tap" throughout the project (refer to Fig. 9 and 10). There was no need for manual proportioning, mixing, and filling of caulking guns. There was also virtually no clean-up because the mixers were disposable. The labor saved was substantial.

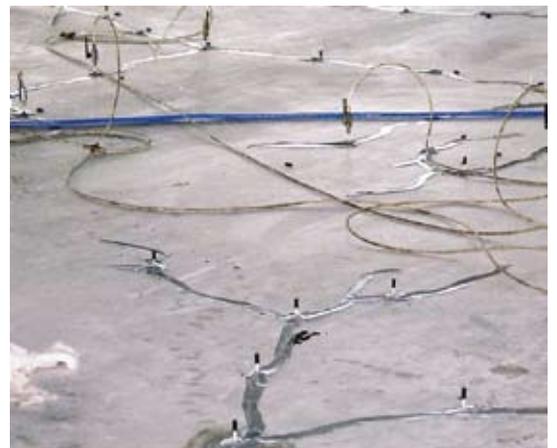
Fig. 11

The injection of numerous (usually nine) ports simultaneously from a single dispenser was a technique that played a major roll in production (refer to Fig. 11). Two workers orchestrated the connections among a welter of porting adapters. The routine called for the port connectors to be managed as a battery; that is, all of the connections were closed, disconnected, relocated, and the valves reopened together. The dispenser kept the resin “on-tap” at a constant and uniform pressure throughout the operation.

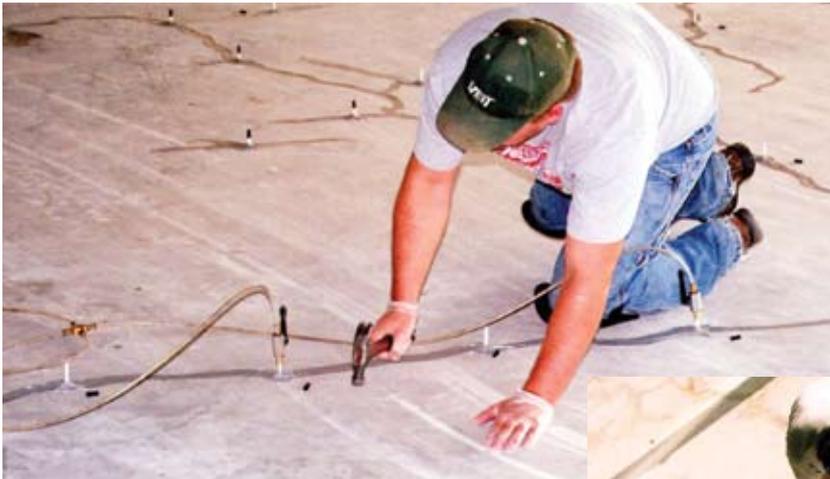
Quality control was ongoing. Filling of delamination voids was confirmed not only by an increasing resistance to penetration as large local voids were filled, but also by tapping of the surface with a hammer (refer to Fig. 12 and 13). The penetration of the resin into the delaminations was closely monitored as the hollow report (so pronounced beforehand) was muted. Cores confirmed the value of this practice

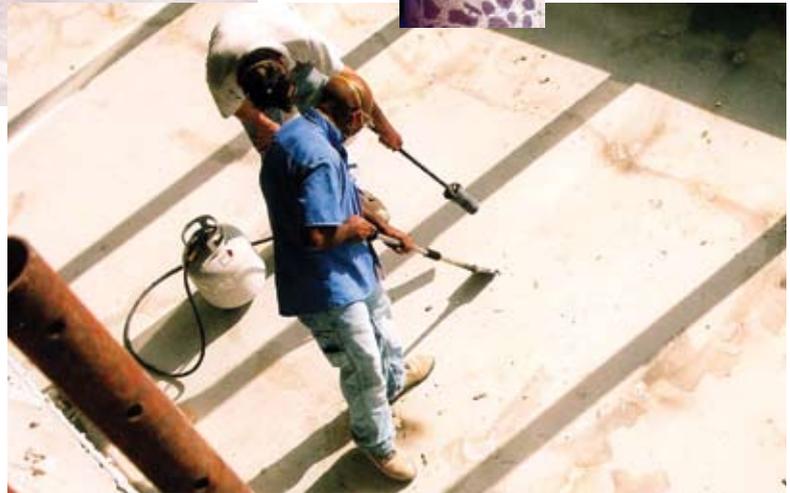
Fig. 14

Following cure of the injected resin (refer to Fig. 14), 200,000 Btu torches were used to soften the sealer so that it could be easily and cleanly shaven from the surface.
